Lorton Landfill-Overlook Ridge Landscape Inspection Report

Inspection Date: December 9, 2020

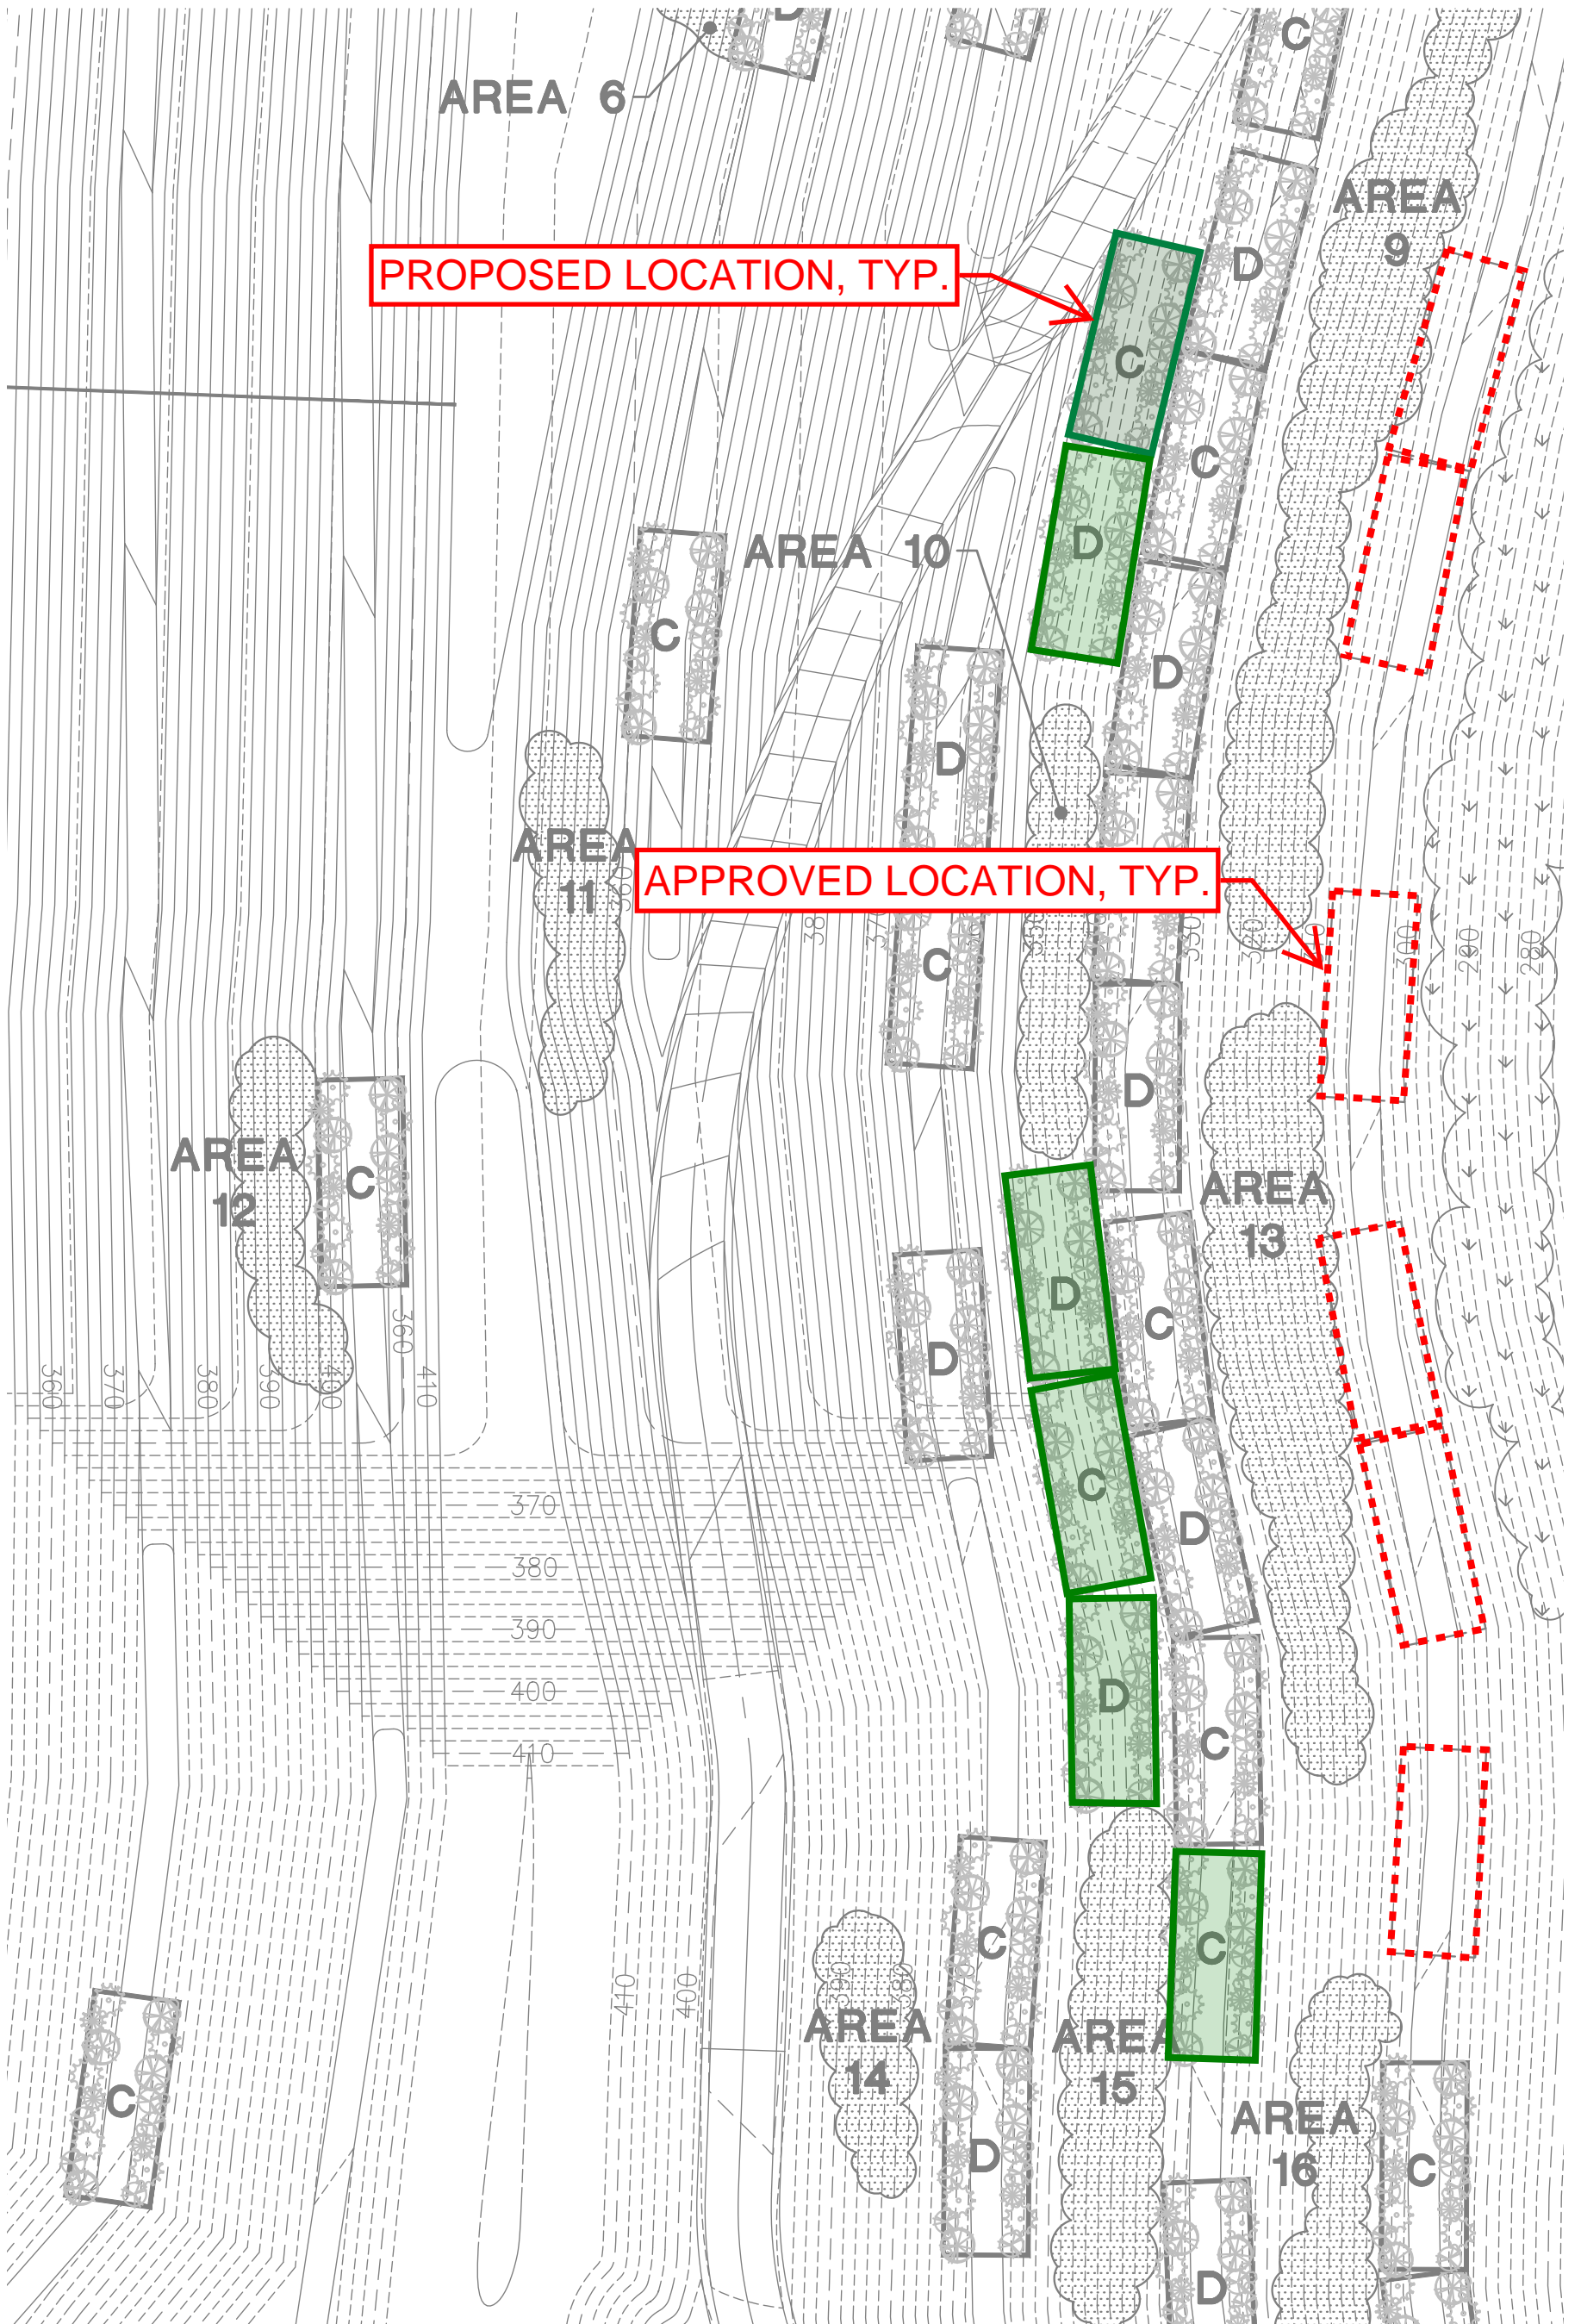
Miscellaneous: Some tags, flagging and support stakes still need to be removed. Tree staking is ongoing. Due to some specific site circumstances, six (6) benches need to be relocated. A relocation plan was submitted to UFMD and approved in consultation with the FCPA (copy attached). Removal of dead trees along the loop road and invasive species management will start shortly after the beginning of next year.
