# Sidewalk and Trail Condition Assessment

Report submitted to Fairfax County  
December 13, 2013

Rinker Design Associates, P.C. • 9385 Discovery Boulevard, Suite 200 • Manassas, Virginia 20109

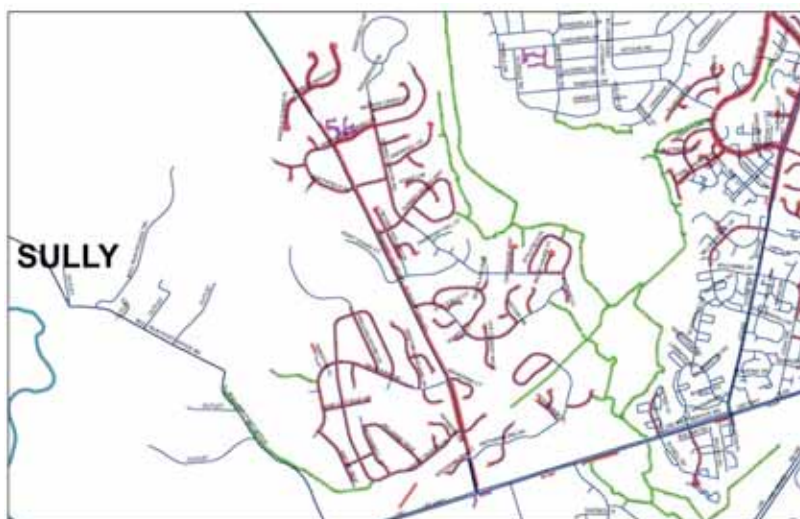
**Location Identification.** The first step in the evaluation process was to identify all Fairfax County maintained facilities. Fairfax County provided all relevant GIS layer information, including layers showing sidewalk locations and maintenance responsibilities. RDA consolidated all the GIS information into separate maps for each Magisterial District. Hard copy maps were distributed to team members for review. The databases created by RDA were stratified by Magisterial District and are compatible with the Fairfax County GIS system. The following exhibit shows an example of the GIS maps created for use in the field.

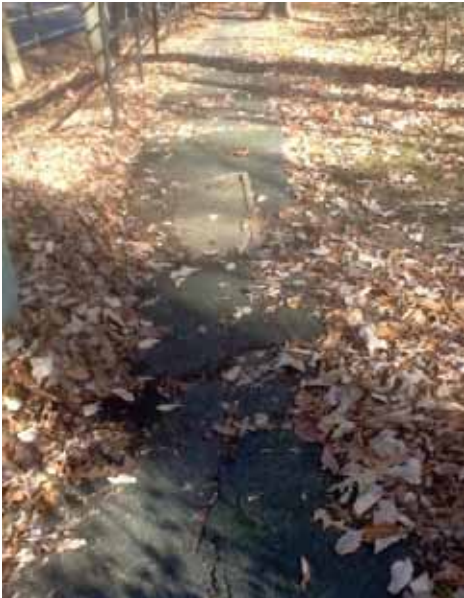
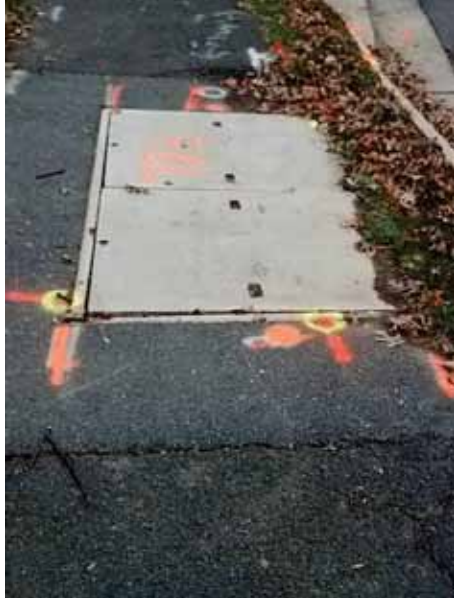
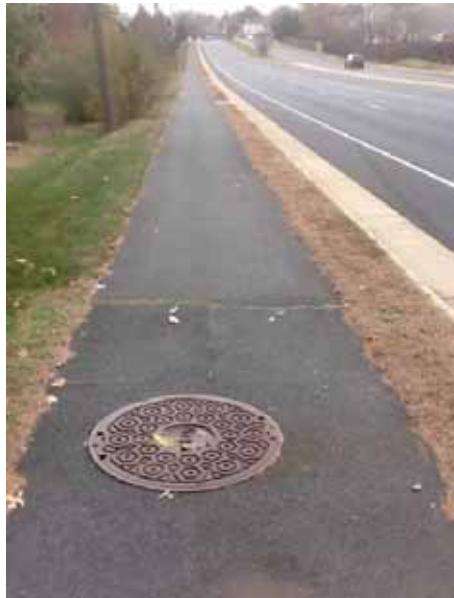
Castings (Concrete)		
Condition: 1 (Poor) High Severity/High Priority	Condition: 2 (Fair) Medium Severity/Medium Priority	Condition: 3 (Good) Low Severity/Low Priority

Castings (Asphalt)		
Condition: 1 (Poor) High Severity/High Priority	Condition: 2 (Fair) Medium Severity/Medium Priority	Condition: 3 (Good) Low Severity/Low Priority

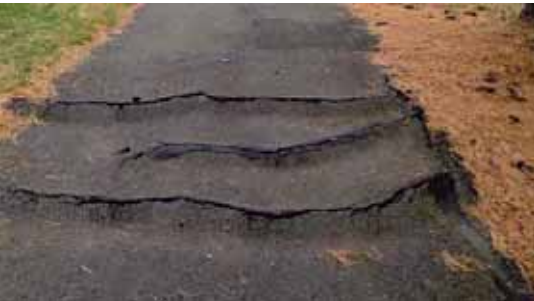
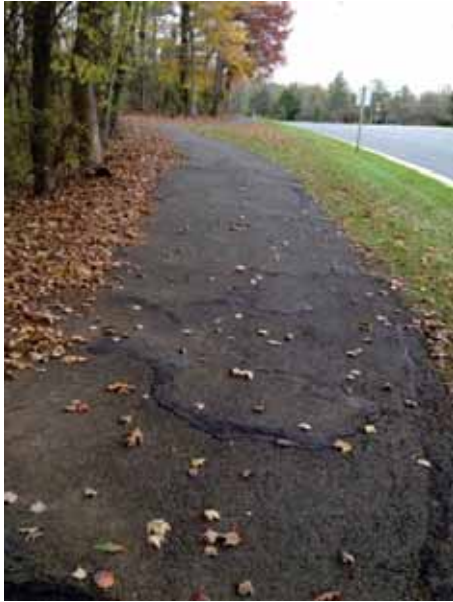
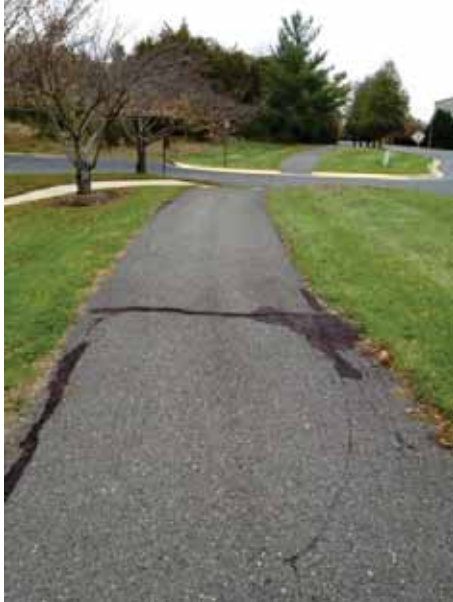
**Figure 3.4**

**Gapping  
(Concrete Only)**

Condition: 1 (Poor) High Severity/High Priority	Condition: 2 (Fair) Medium Severity/Medium Priority	Condition: 3 (Good) Low Severity/Low Priority

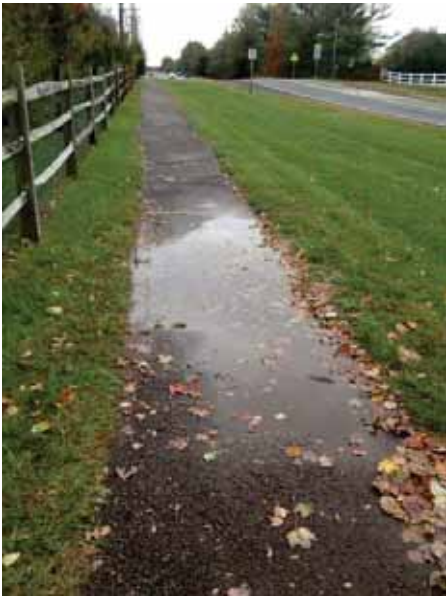
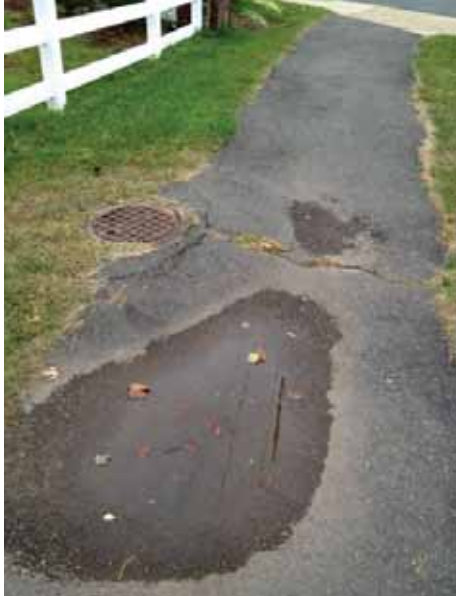
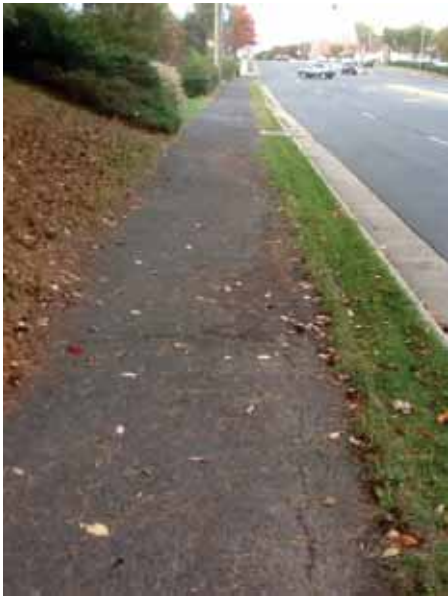
**Figure 3.10**  
Surface Scaling  
(Concrete)

Condition: 1 (Poor) High Severity/High Priority	Condition: 2 (Fair) Medium Severity/Medium Priority	Condition: 3 (Good) Low Severity/Low Priority

Surface Scaling (Asphalt)		
Condition: 1 (Poor) High Severity/High Priority	Condition: 2 (Fair) Medium Severity/Medium Priority	Condition: 3 (Good) Low Severity/Low Priority

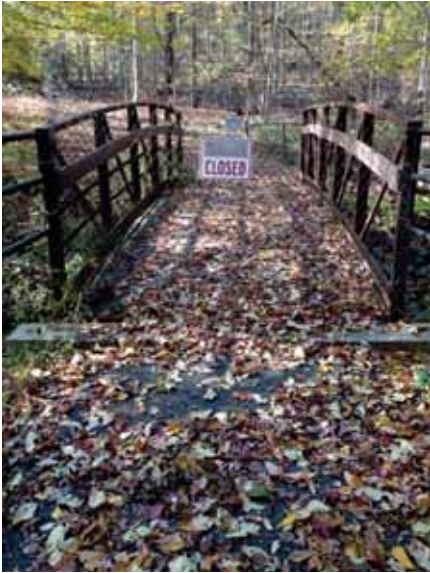
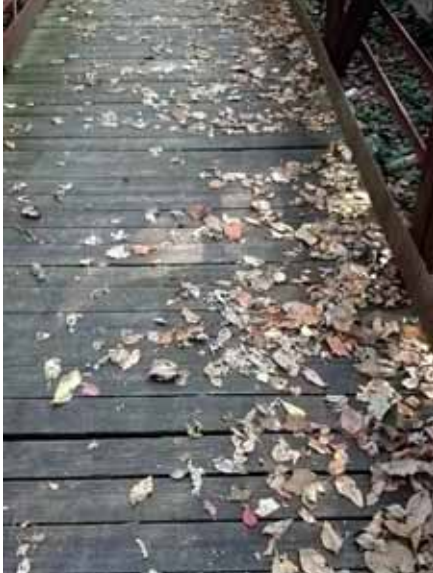
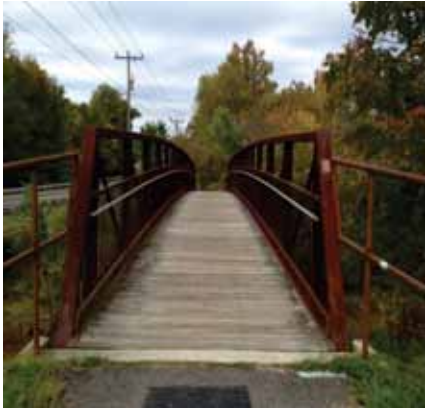
**Figure 3.12**  
**Bridges**

Condition: 1 (Poor) High Severity/High Priority	Condition: 2 (Fair) Medium Severity/Medium Priority	Condition: 3 (Good) Low Severity/Low Priority
